# A STUDY OF THE FAILURE OF JOINTS IN COMPOSITE MATERIAL FUEL CELLS DUE TO HYDRAULIC RAM LOADING

# NAVAL POSTGRADUATE SCHOOL

# THESIS

June 1976

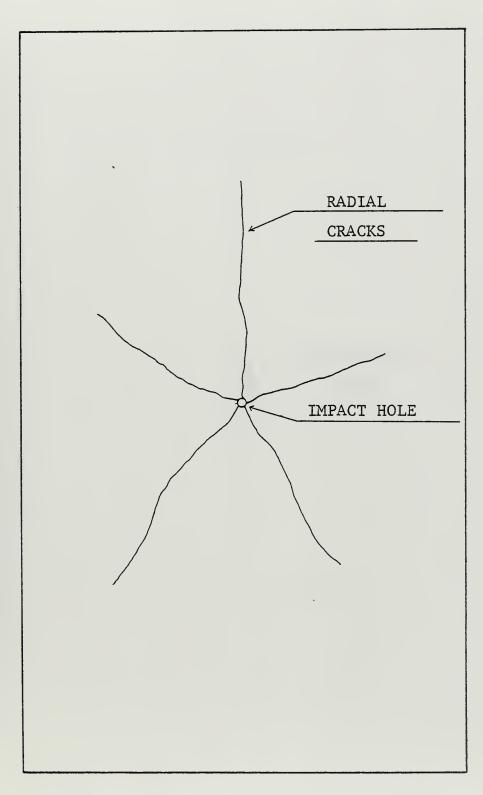
Figure II.1 RADIAL CRACK FAILURE

At present, five main types of fracture of the composite fuel tank wall have been identified. Although there is always some form of hole in the wall due to the penetration of the projectile, different crack types may occur. First, there is the possibility of radial cracks extending out

from the hole, as illustrated in Figure II.1. Second, there is the possibility of a lengthwise crack with extensive delamination of the material around the hole, as seen in Figure II.2.

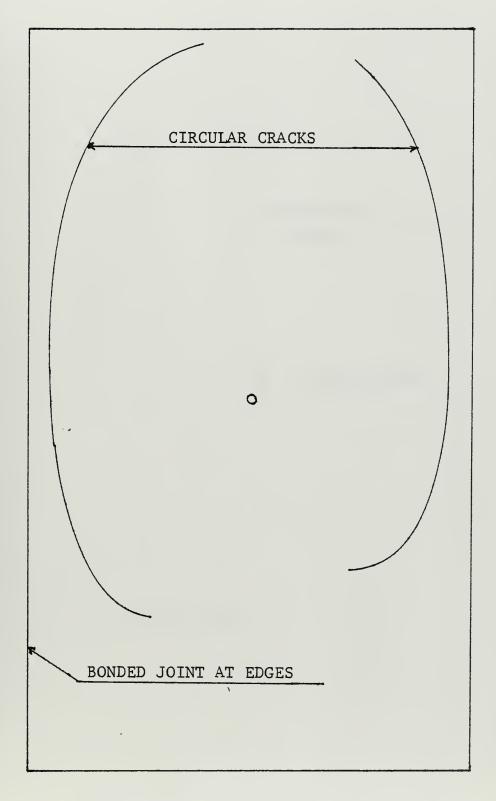
Figure II.3 CIRCULAR CRACK FAILURE

The remaining modes of fracture do not occur around the hole, are significantly influenced by the hydraulic ram loading, and indicate a more serious loss of structural integrity than the first two modes of fracture. The third fracture type has long circular cracks near the edges or attachments of the plate, where a bonded attachment technique was used. It is illustrated in Figure II.3. fracture in the fourth case is very similar to that of the third case. This type also has long cracks along the edges of the plate, where the attachment to the supporting members is made, but the attachment technique used here was one of clamped edges, and the fracture has almost led to a breakout of the entire plate, as illustrated in Figure II.4. main difference between the third and fourth types of fracture is a difference in the method of attachment of the plate. In the third case, the attachment was a built up, interlaminarly bonded joint. The attachment in the fourth case was a clamped edge.

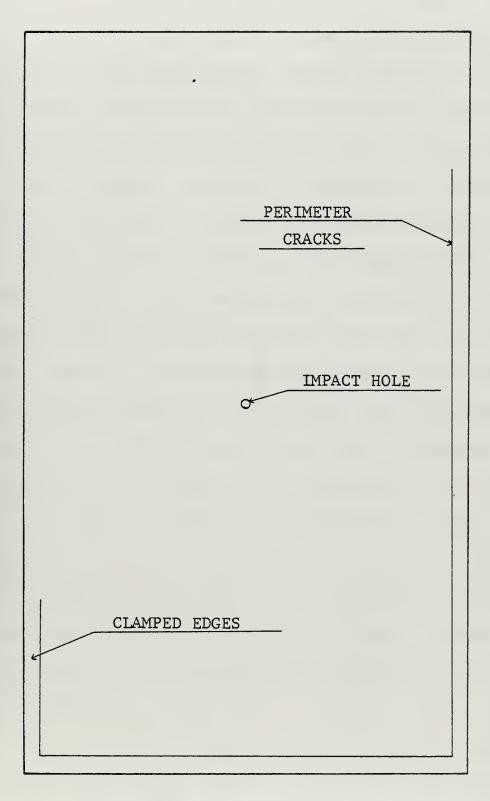
Figure II.4 EDGE LENGTH CRACK FAILURE

A crack or fracture, such as the one along the clamped edge of a composite plate, shown in Figure II.4, is transverse in some layers, and longitudinal in others. For cracks and fractures in composites due to the hydraulic ram loading, where the plate failed at the attachments, the stresses in the material are dependent upon N, M, and Q, and the combination of the three makes the prediction of a particular failure mode very difficult.

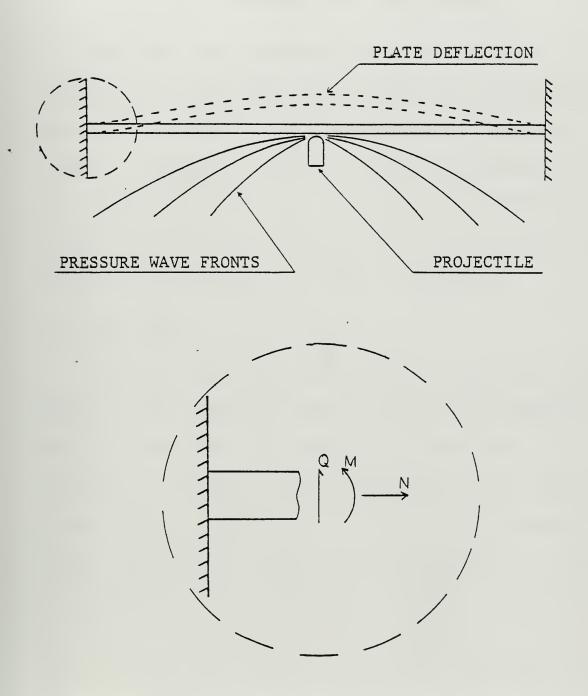
Figure II.5 HYDRAULIC RAM LOADING ON A PLATE

of the plate, the attachments are one of the critical areas of failure for a fuel tank of composite construction. An examination of the loading on the plate by the hydraulic ram also reveals that the attachment areas of the plate will be critical failure areas. The fluid pressures on the plate, created by the penetrating projectile, will produce three types of internal loads in the plate, membrane tensile and shearing forces, (N), thickness shearing forces, (Q), and bending and twisting moments, (M). This type of pressure loading, as seen in Figure II.5, can create high stress levels at the edges of the plate where the plate is restrained.

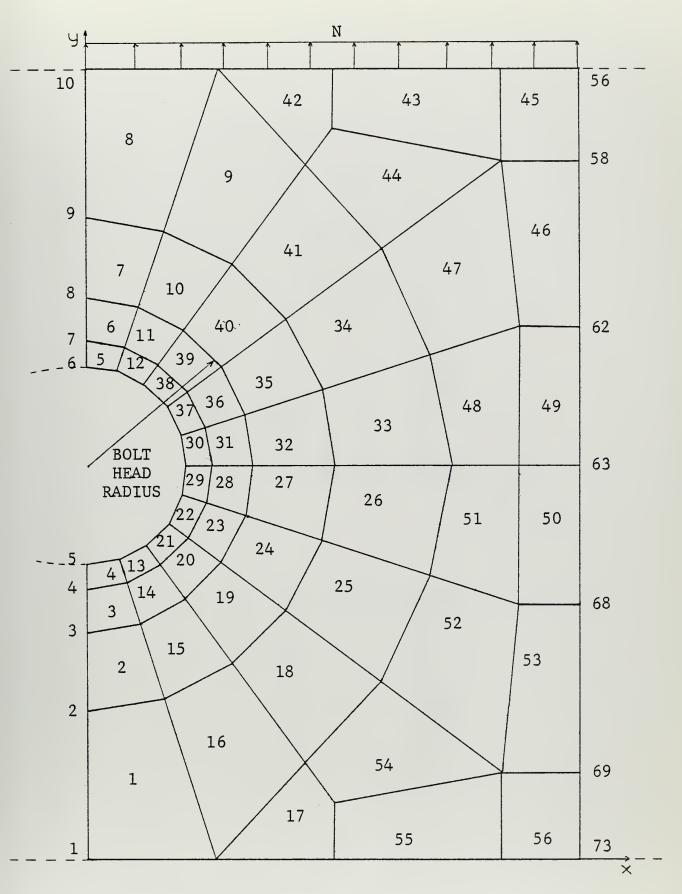
Figure VI.A.1 PLATE MODEL

Since the area of the joint is small, and since it is symmetrical, only 56 plate elements and 73 nodes were used to model one-half of the joint. Figure VI.A.1 shows the joint model with the layout of the nodes and the numbering

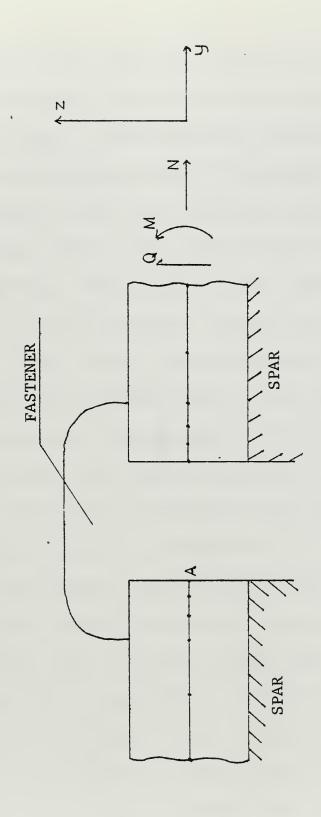
Figure VI.A.2 JOINT LOADING

It was assumed that the fastener would not fail, but would remain rigid. The skin was permitted to move in the y-direction except where the fastener would restrict such movement, such as at point A, Figure VI.A.2. It was also assumed that the fastener would restrain the movement of the plate in the z-direction where the fastener head overlapped the plate, and it was also assumed that the fastener did not permit any rotations where it overlapped the plate. The boundaries of the model, nodes 1 through 10, and nodes 56, 58, 62, 63, 68, 69 and 73 were not permitted displacements in the x-direction or rotations about the y-axis, due to the symmetry of the problem. The edge between nodes 10 and 56 was where the unit loads/unit length were applied,

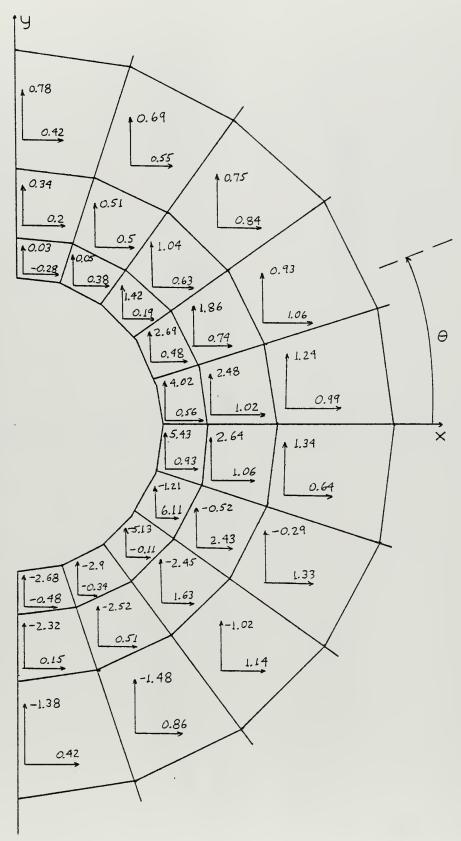
Figure VI.A.3 STRESS FIELD AROUND HOLE DUE TO N

Figures VI.A.3, VI.A.4, and VI.A.5 show how the stresses in the plate, Sxx and Syy, varied around the hole for a unit tensile force/unit length. Although the joint is somewhat similar to a plate with a hole, the fastener was available to resist the tensile forces put on the plate; hence, higher stress concentrations than those of a plate with a hole in it were the result. Since only the fastener restricts deflection in the y-direction, all of the tensile force is picked up at the fastener, causing stress concentrations near five in compression in the plate.

Not only were there large stress concentrations in compression where the fastener picked up the load, but there were also large stress concentrations in tension in the ydirection of approximately 5.5. Since there is a hole, and the loads will not be picked up until they get around the hole, large stress concentrations will exist even where the fastener has no effect in restricting deflections in the y-direction. Results of the analytical studies of Howland and Theocaris (Ref. 27 indicate that stress concentrations near five or five and a half are quite close to

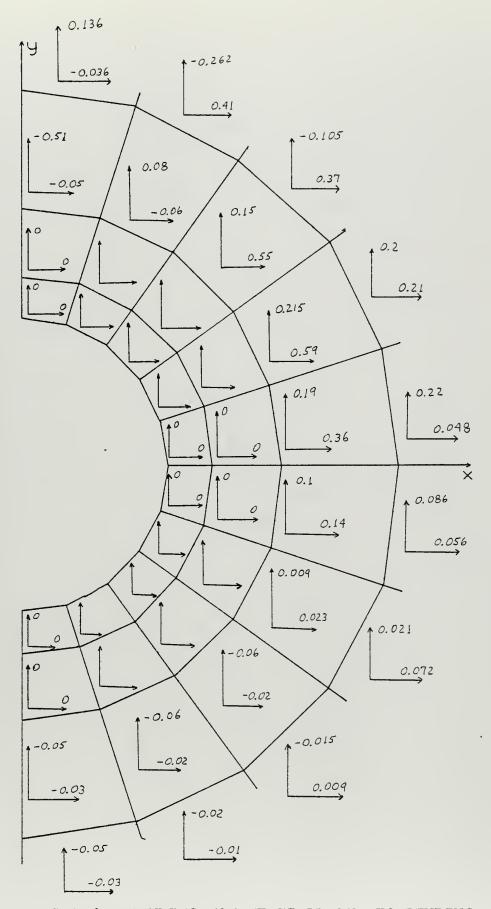
Figure VI.A.6 BENDING MOMENT FIELD DUE TO BENDING MOMENT

Figures VI.A.6 and VI.A.7 show how the moments due to the applied bending moment and the applied transverse shearing forces, respectively, are distributed through the plate. No moments were found in the section of the plate where the bolt head was influencing the material rotation, as one would expect. The important idea to remember about the moment field is that if the bending moment and the thickness shearing forces are the most critical loads in the joint, then these figures will give only a very basic idea of what one would expect for the bending stresses around the hole. Unfortunately, since the program does not give thickness shearing stress resultants for either the unit transverse shearing force/unit length or the unit bending moment/unit length (only moment resultants are printed) it is not possible to determine the thickness shearing force concentrations around the bolt hole for these two loads using the plate model. The way one can determine the transverse shearing stress state around the hole for these two loads is to use a three-dimensional finite element model of the joint using brick elements.

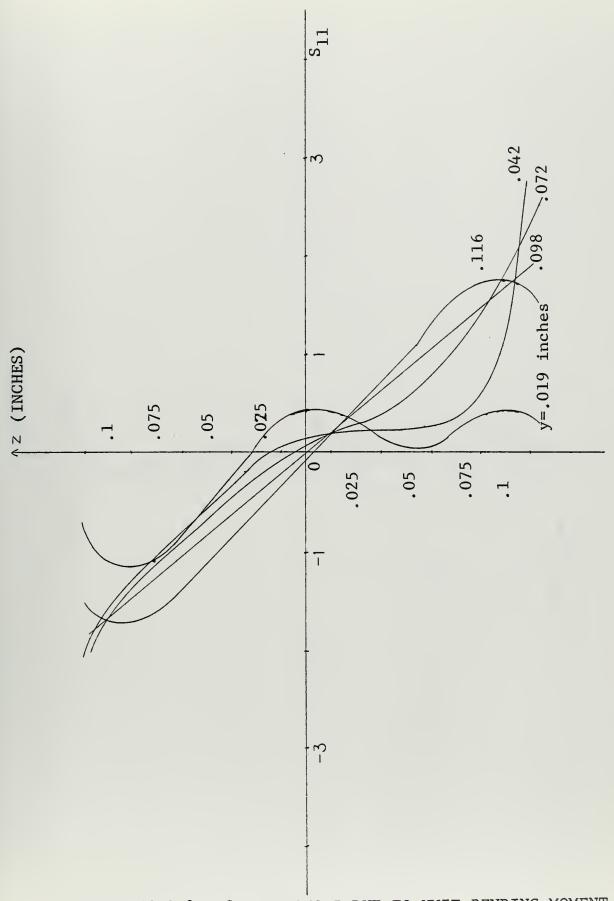
Figure VI.B.2 S<sub>11</sub> VERSUS Z DUE TO UNIT BENDING MOMENT

Figures VI.B.2 and VI.B.3 show the stress distribution through the thickness and along the y-axis for a unit bending moment/unit length. The results indicate that the bending moment is not going to be the most critical load on the

joint. The maximum stress concentrations produced by the bending moment are only about Z, insignificant even in comparison with those produced by a unit tensile force/unit length on the plate. This maximum stress concentration is in compression at the edge of the fastener head, where the fastener can first pick up the load. One would expect these stresses in the z-direction, due to the bending moment, to be zero. Although the computer analysis does not show that they are zero, the values up to the fastener head are very close to zero. Once the fastener starts to restrict the deflections, though, there is a gradual increase in the stresses near the fastener body. The stresses in the y-direction, due to the bending moment, would be linear in a normal plate analysis. Since there is a fastener, though, the stress changes from what is essentially a linear distribution in z, to an odd distribution which is caused by the fastener re-straining the deflections of the plate. majority of the load is picked up at the edge of the fastener head and then decreases towards the fastener body.

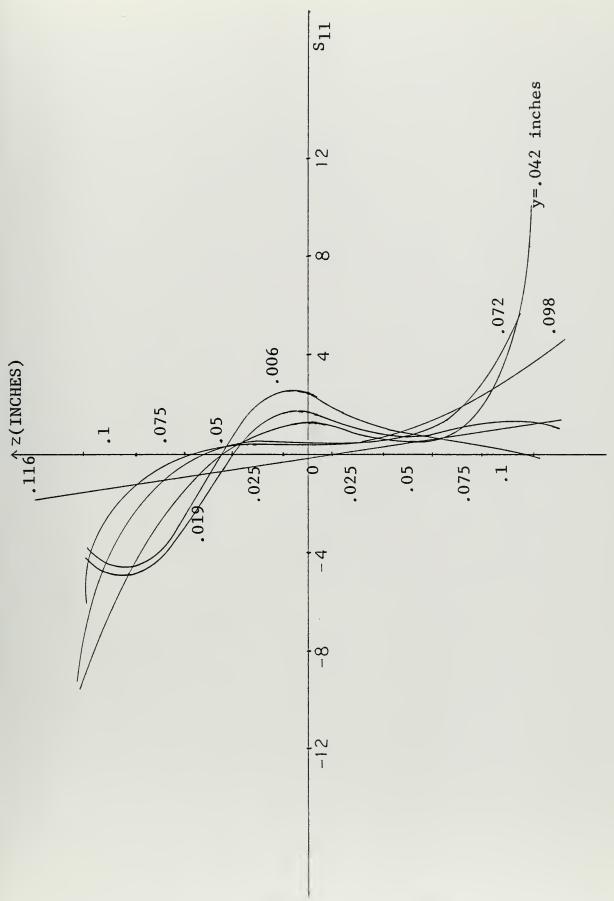
Figure VI.B.4  $\,$  S<sub>11</sub> VERSUS Z DUE TO UNIT THICKNESS SHEAR

Figures VI.B.4, VI.B.5, and VI.B.6 show how the stress varies through the thickness and along the y-axis for the thickness shearing force/unit length. The results indicate that the thickness shear may be significant in the failure

of the joint due to hydraulic ram loading. As one would expect, the stress in the material in the z-direction is essentially zero where there is no restraint at the bottom of the plate, but it increases almost linearly to its maximum where the fastener head restricts the displacements and picks up the transverse shearing loads. The stresses in the y-direction due to the transverse shearing force start off in a linear distribution through the thickness, but rapidly change from linear due to the re-straining effect of the fastener.
